Nº 139 SERVICE BULLETIN

DATE: May 16, 2003

SUBJ: F21 (50vdc) Fuse Blows Intermittently, System Checks OK on

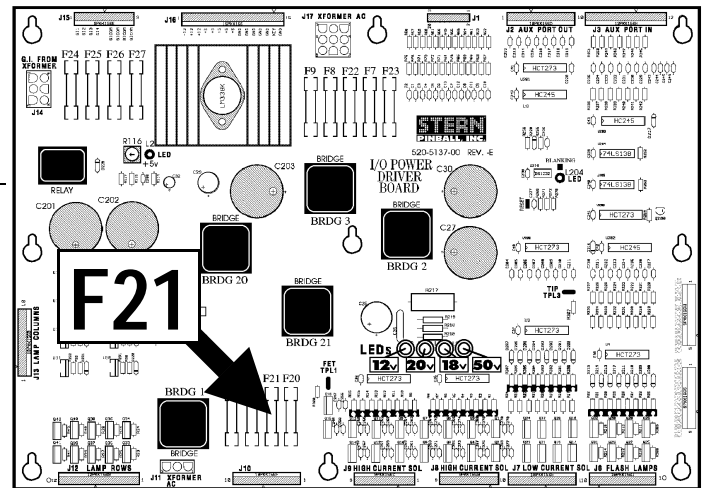
I/O Power Driver Board ▼

The game will not serve the ball into Shooter Lane. After checking the fuses on the I/O Power Driver Board, the F21 Fuse (3A 250v Slo-Blo) is found to be blown. The fuse is replaced and everything works properly until the fuse blows again within a period of 1 week to a month or more.
